## **Limited Visual Dam Safety Inspection Summary Report**

**MA-139**

**Maui Field 290 Reservoir**

**May 2006**

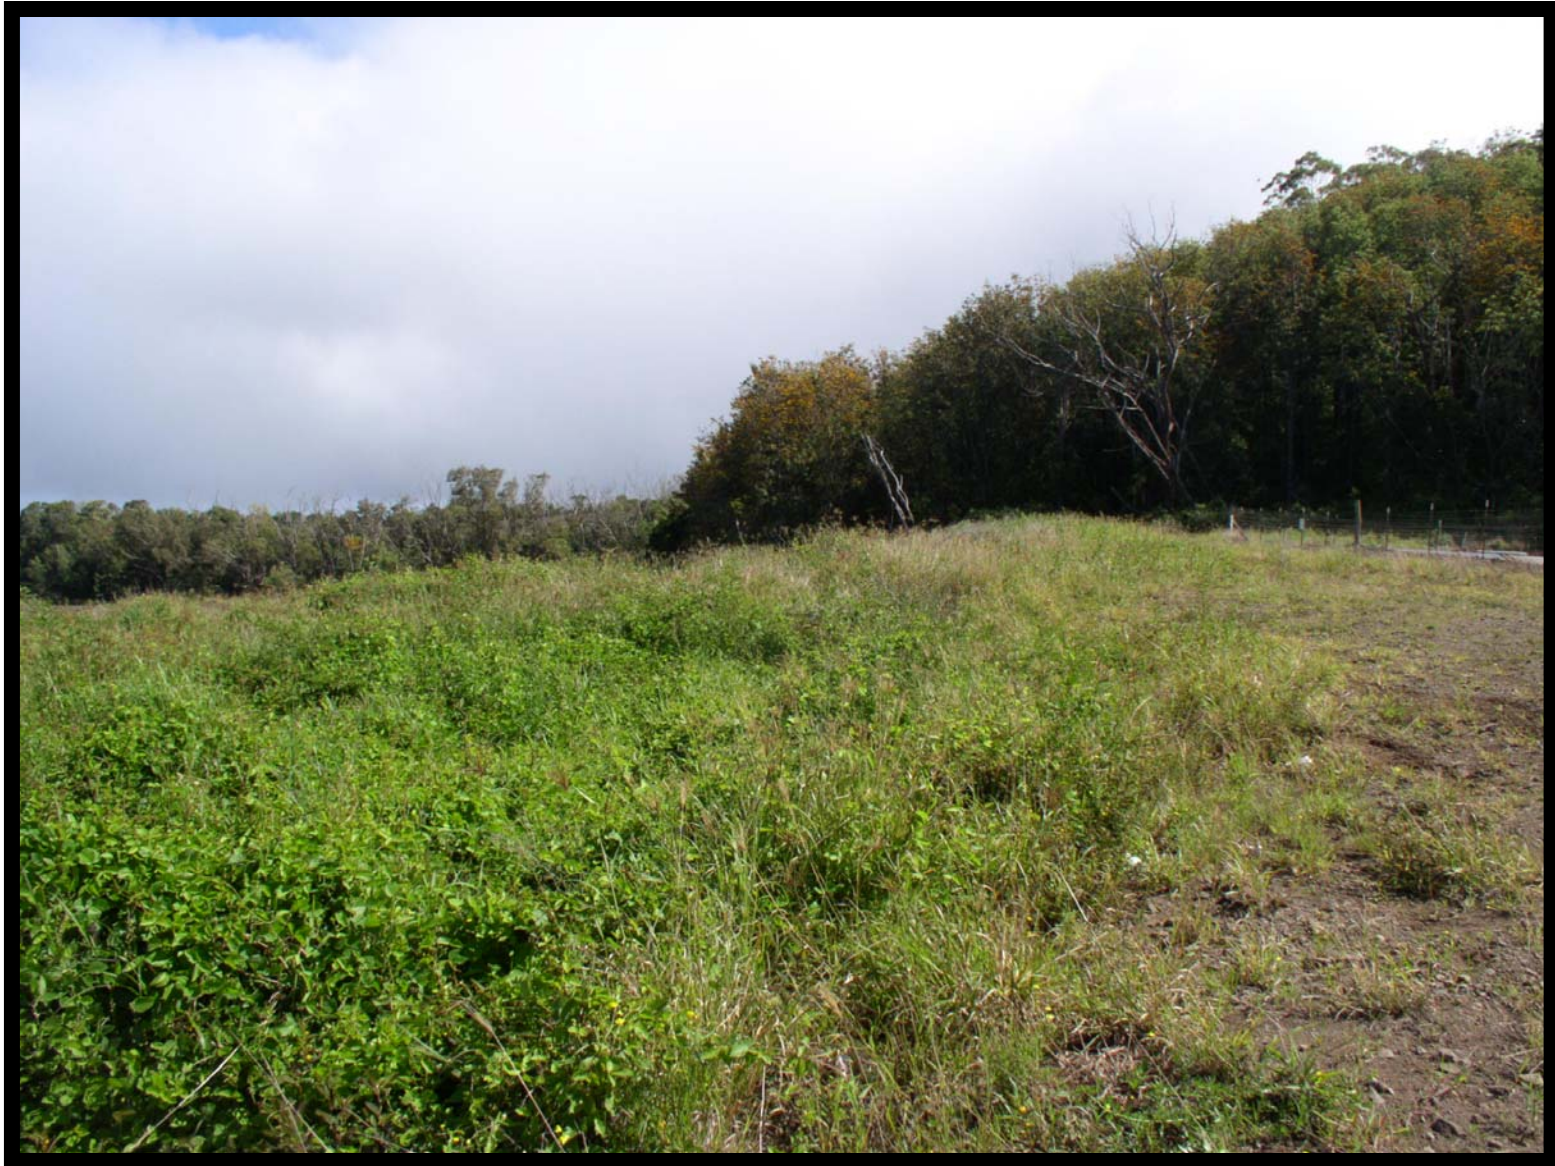
The downstream slope was about 1 on 4. The downstream slope was not entirely visible due to tall grass and bushes. There was access to the downstream slope by a walking. There was no slope protection observed on the downstream slope. Erosion was not observed on the downstream slope; however the slope was not entirely visible. Sinkholes were not observed on the downstream slope; however the slope was not entirely visible. Seepage was not observed on the downstream toe; however the slope was not entirely visible.

- a. The downstream slope appeared to be in fair to poor condition and requires corrective action.
- b. The down stream slope was not visible due to high grass and bush vegetation. Clear high vegetation and maintain low to enable easy visual inspection.

139 Downstream slope and cover - View of DS slope angle and heavy brush and tall grass cover.

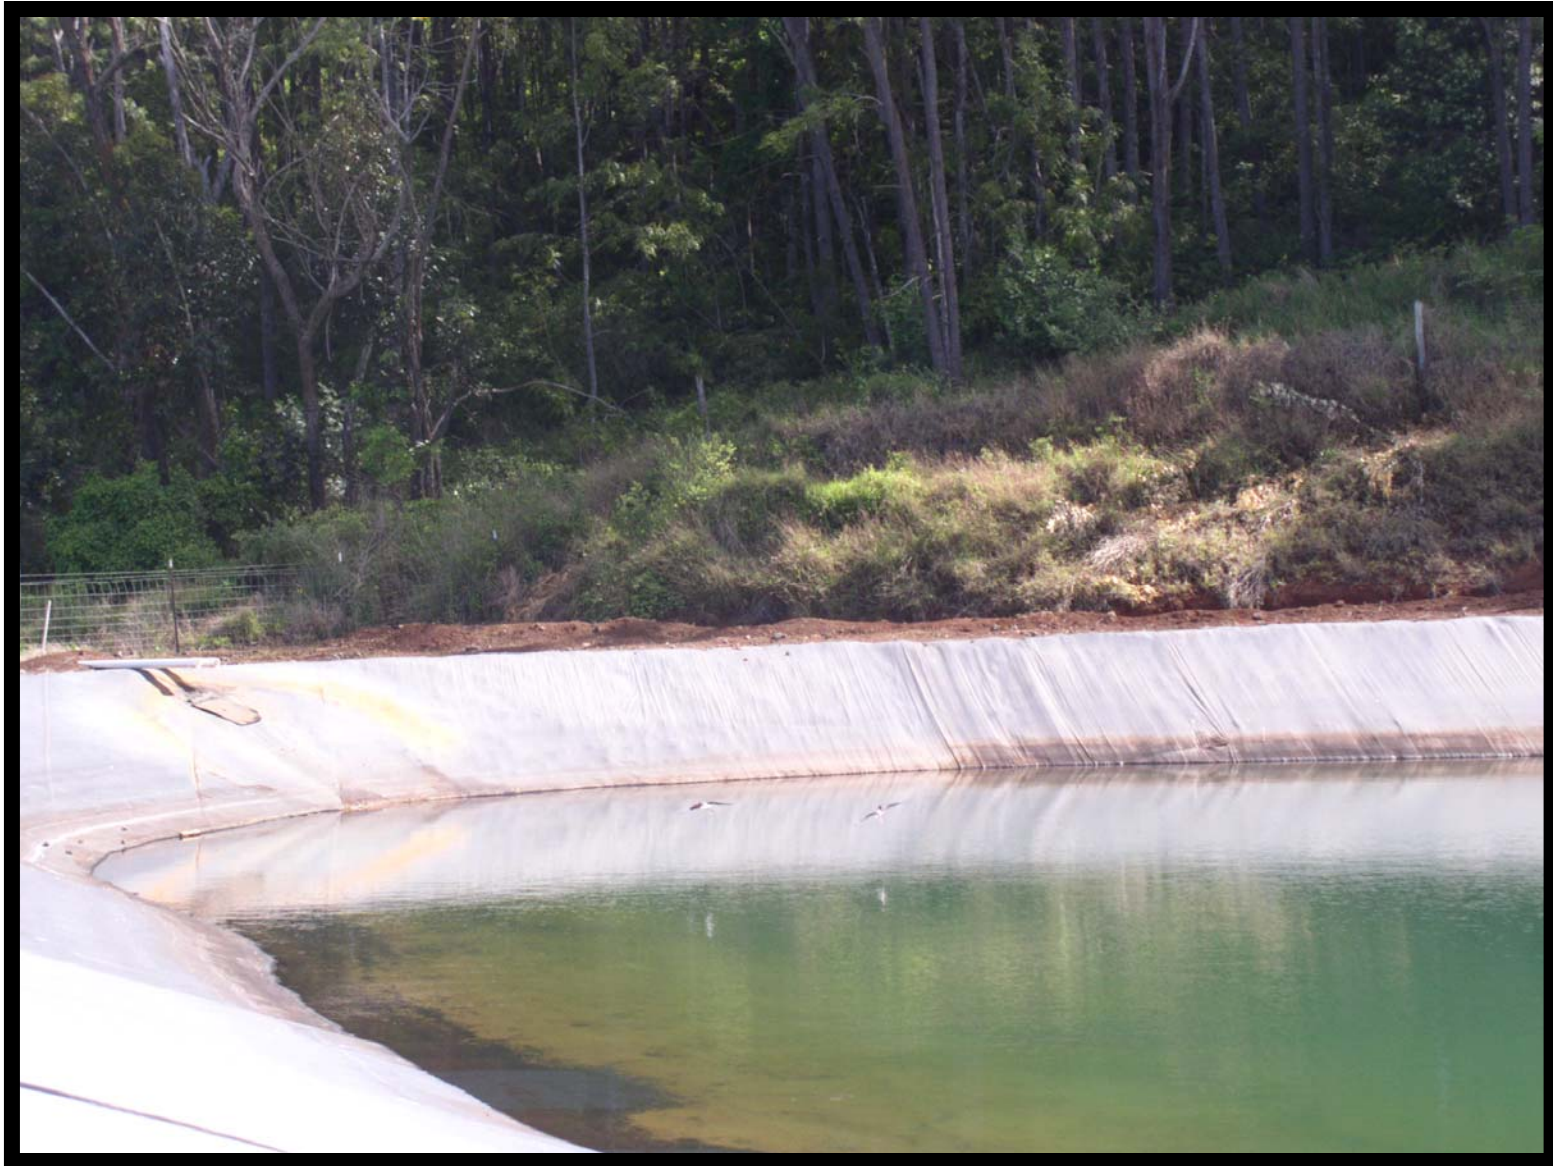
139 Downstream right end upslope - View of right end of dam showing two 4-inch inlet pipes

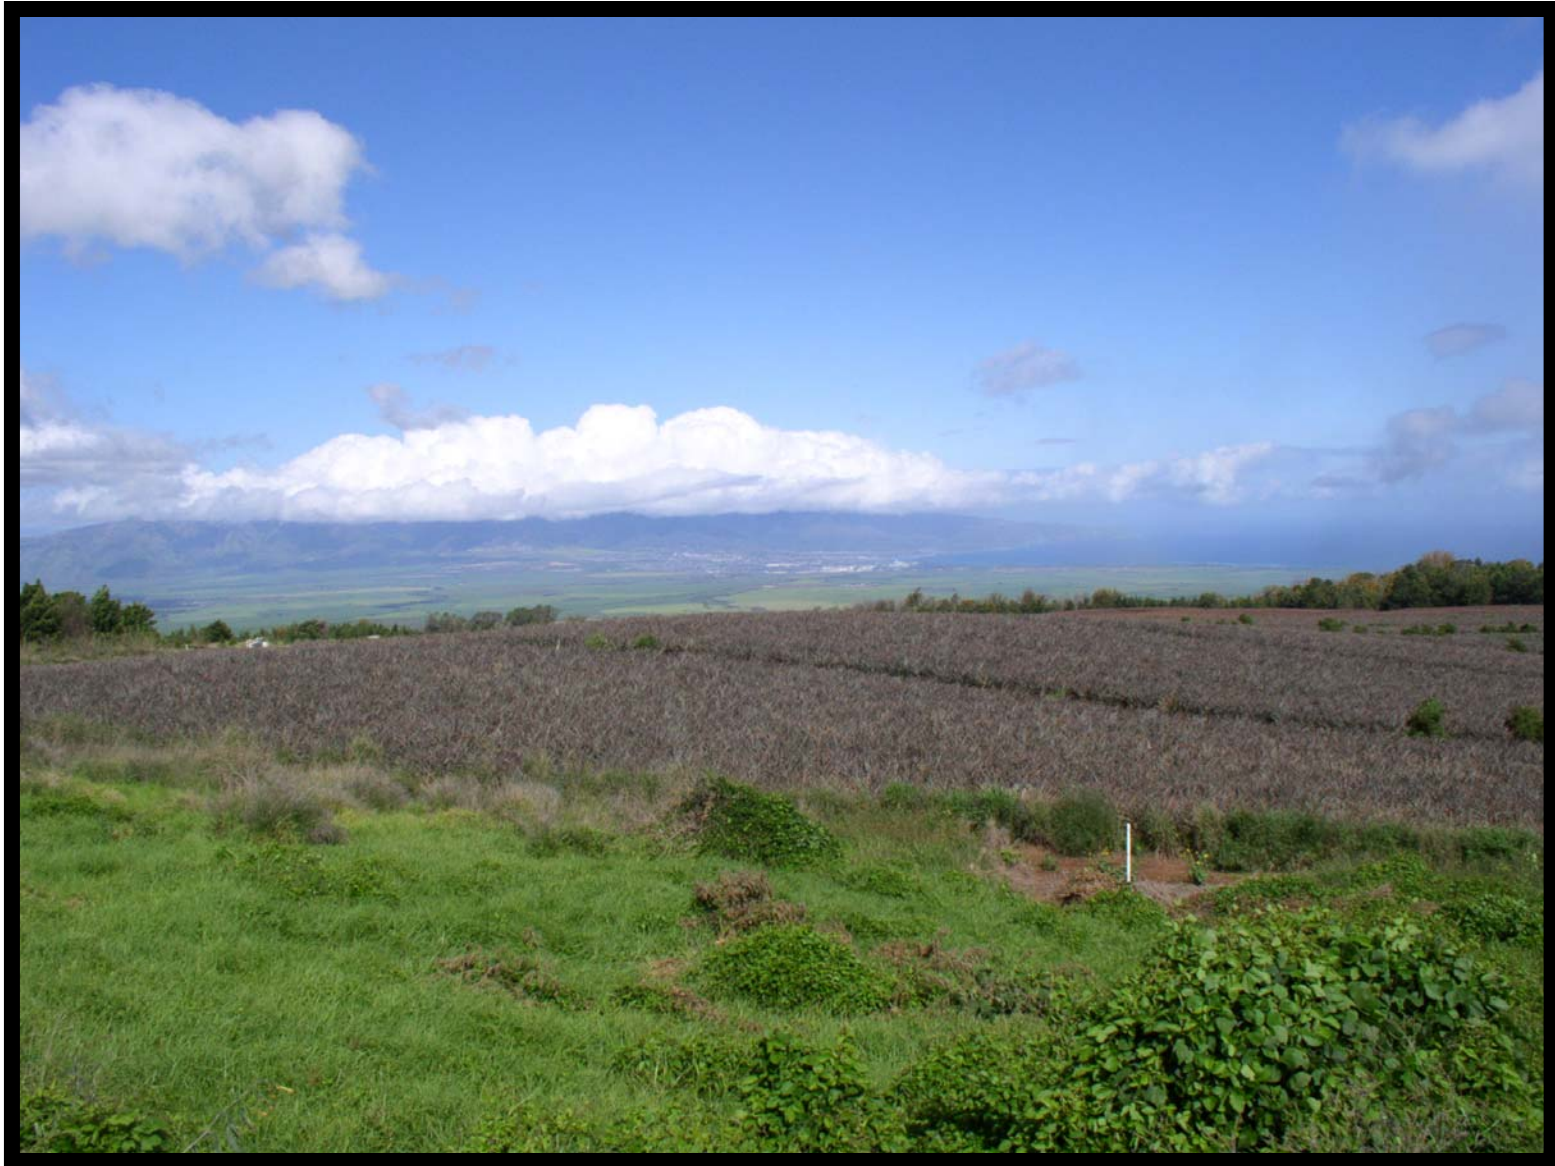
139 Downstream view below dam slope

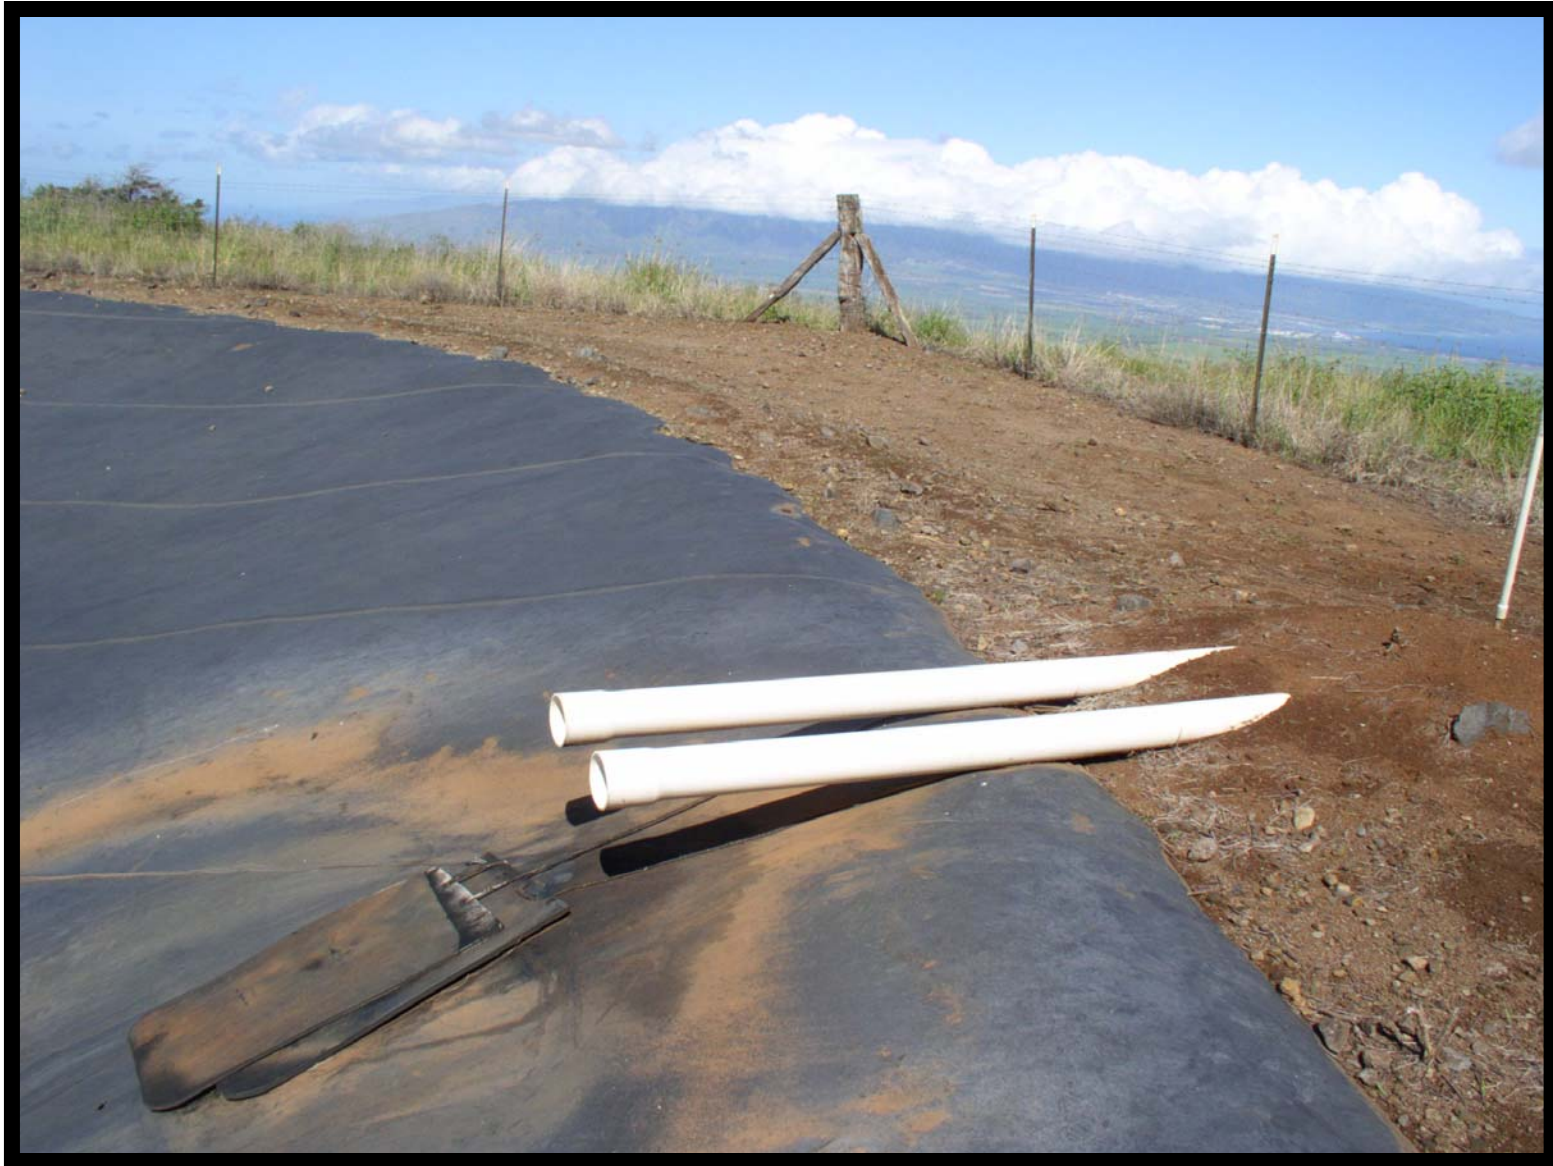
139 Dual 4 inch inlet pipes close-up for reservoir

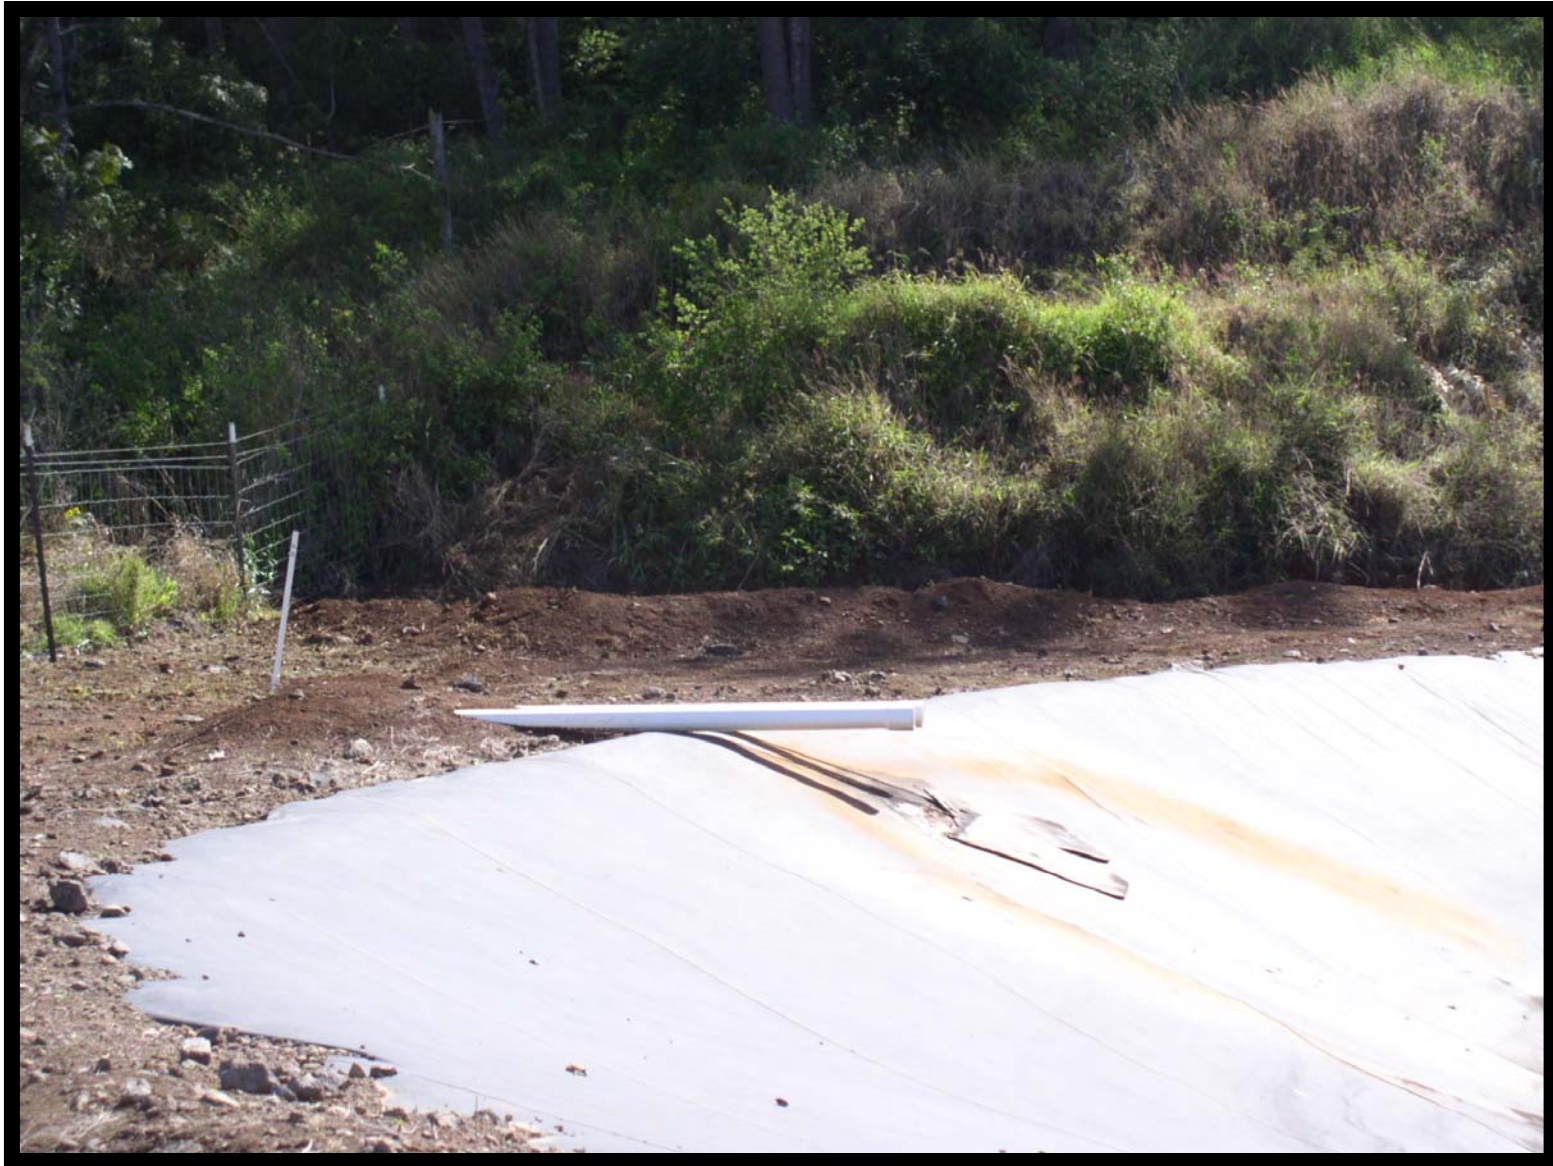
139 Inlet pipes – looking upstream

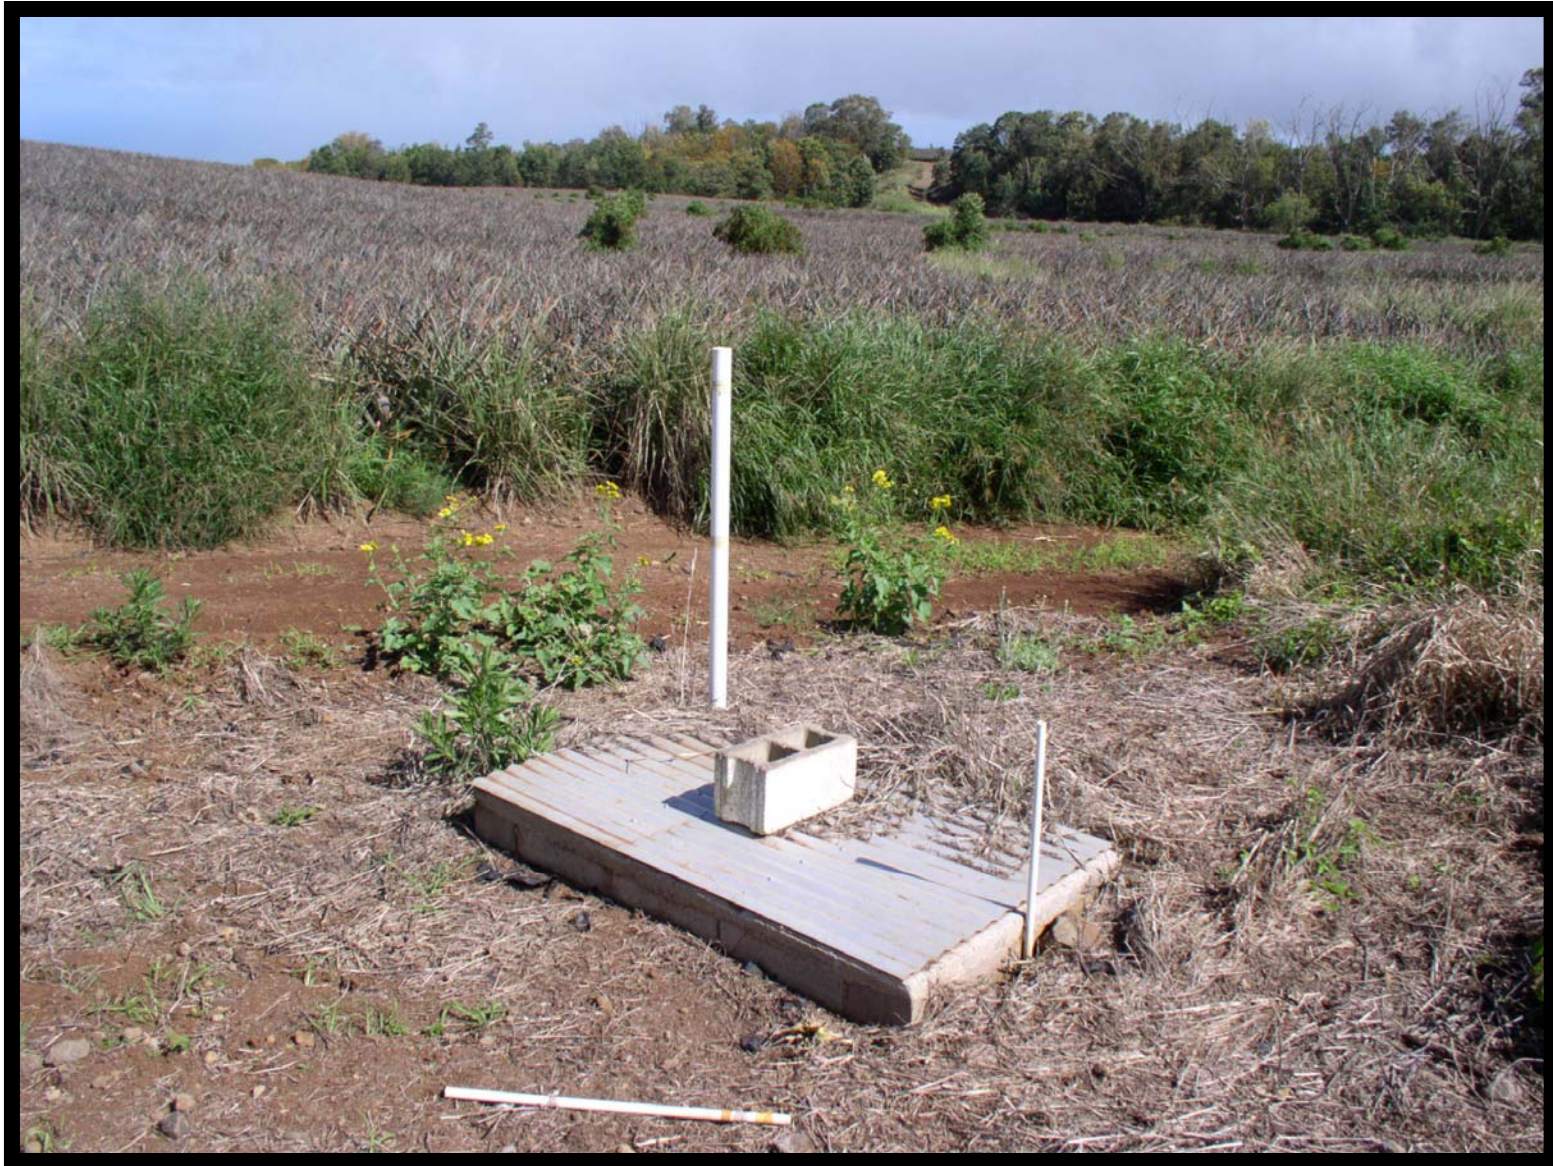
The outlet consisted of a submerged 8-inch diameter PVC pipe but was not inspected in detail, not tested. The outlet works was controlled via a valve on the downstream side of the dam. Seepage was not observed flowing near the exit of the outlet works from the dam.

- a. The outlet works were not tested.
- b. The outlet works appeared to be in satisfactory condition, no corrective actions are required at this time.

139 Outlet control valve box located downstream of dam

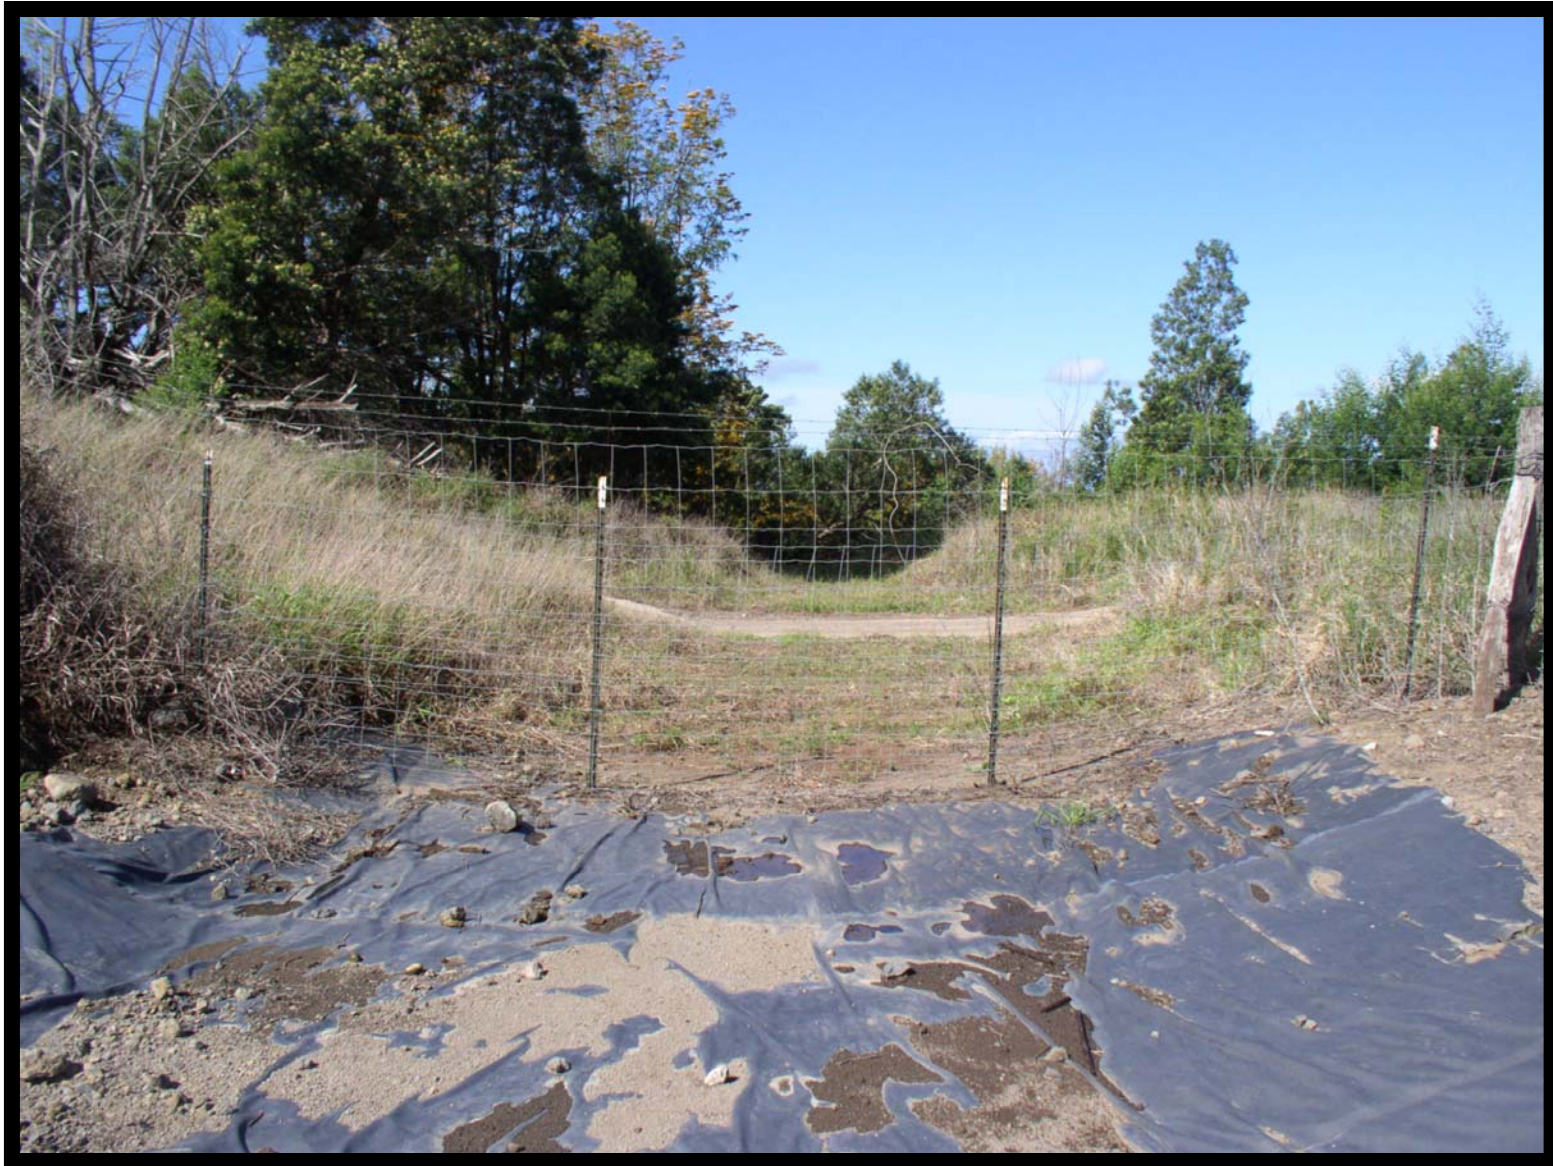
This spillway consisted of an uncontrolled channel that began with a HDPE liner and transitioned into native ground near the left end of the dam. The spillway channel then feeds a drainage gouge that runs along the left downstream edge of the downstream toe. The spillway approach was clear. There was no erosion observed near the spillway. The downstream vegetation appears to be primarily woody vegetation.

- a. The Spillway appeared to be in satisfactory condition, no corrective actions are required at this time.

139 Spillway channel leading to gouge

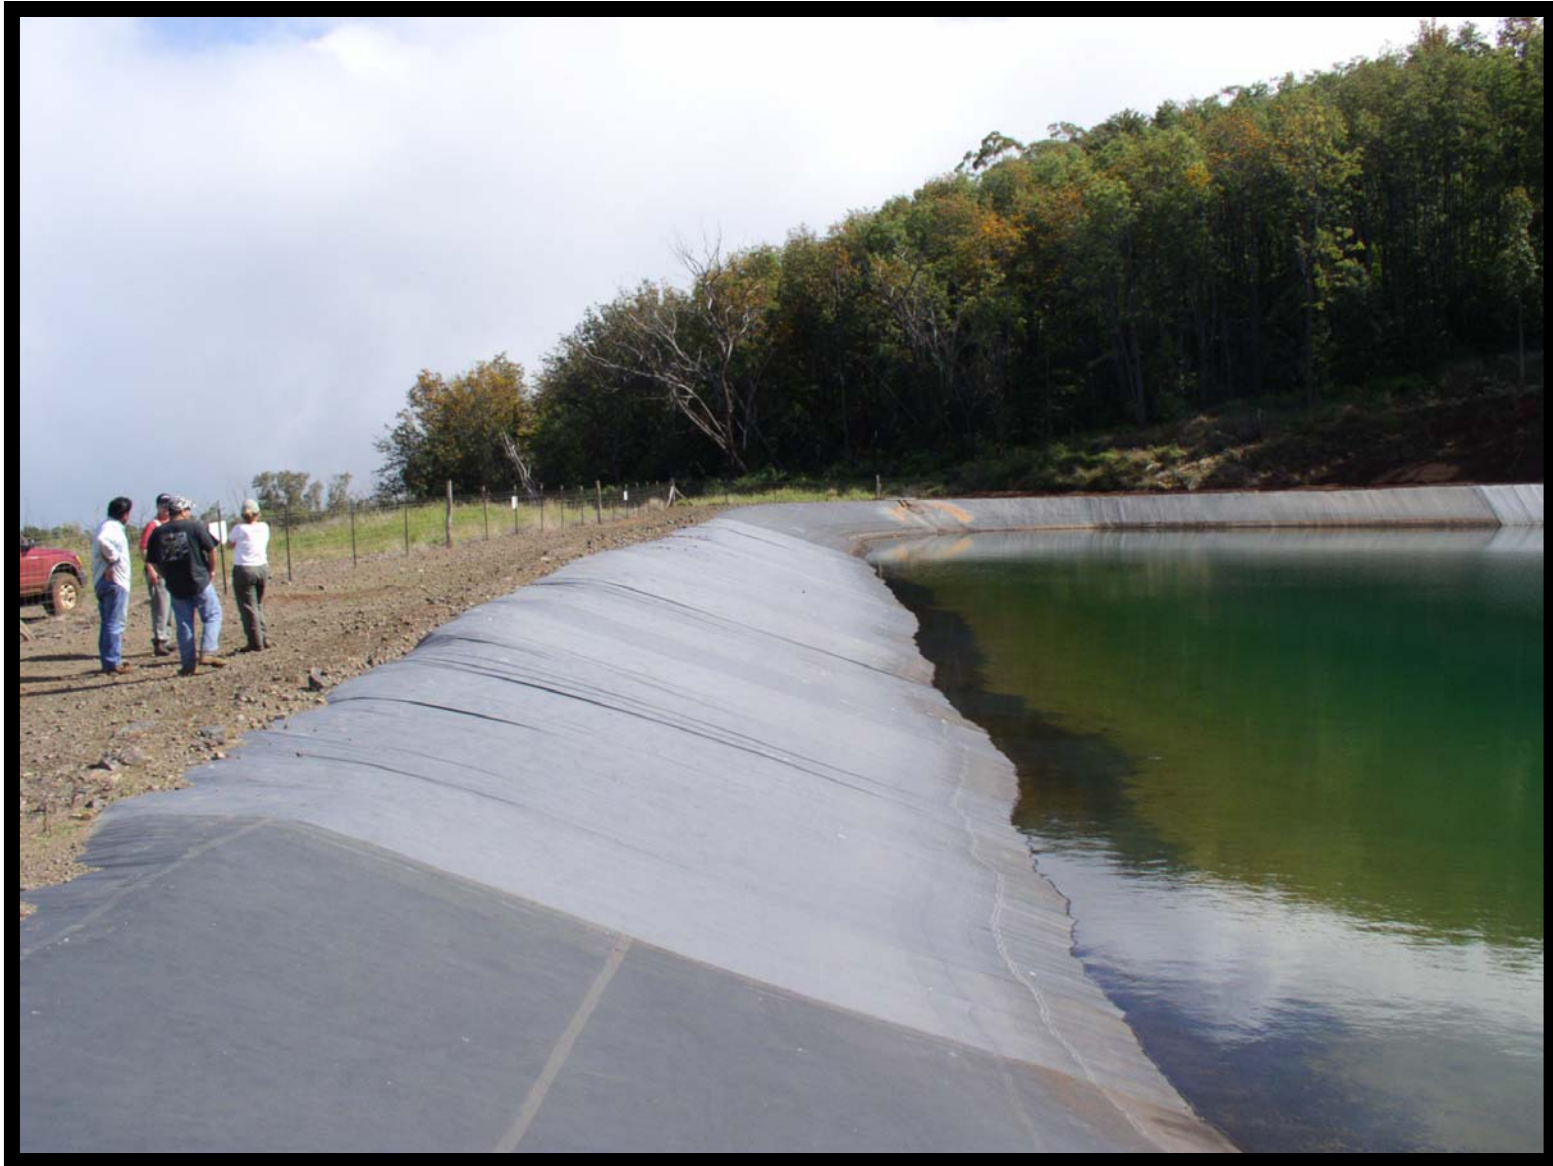
The upstream slope varied in slope and ranged from a 2H to 1V. Slope protection consisted of the HDPE liner. Erosion were not observed, the slope was entirely visible. Cracks were not observed, the slope was entirely visible. Sinkholes were not observed, the slope was entirely visible.

- a. The upstream slope appeared to be in satisfactory condition, no corrective actions are required at this time.

139 Upslope and crest - View of lined upslope with HDPE liner and crest view

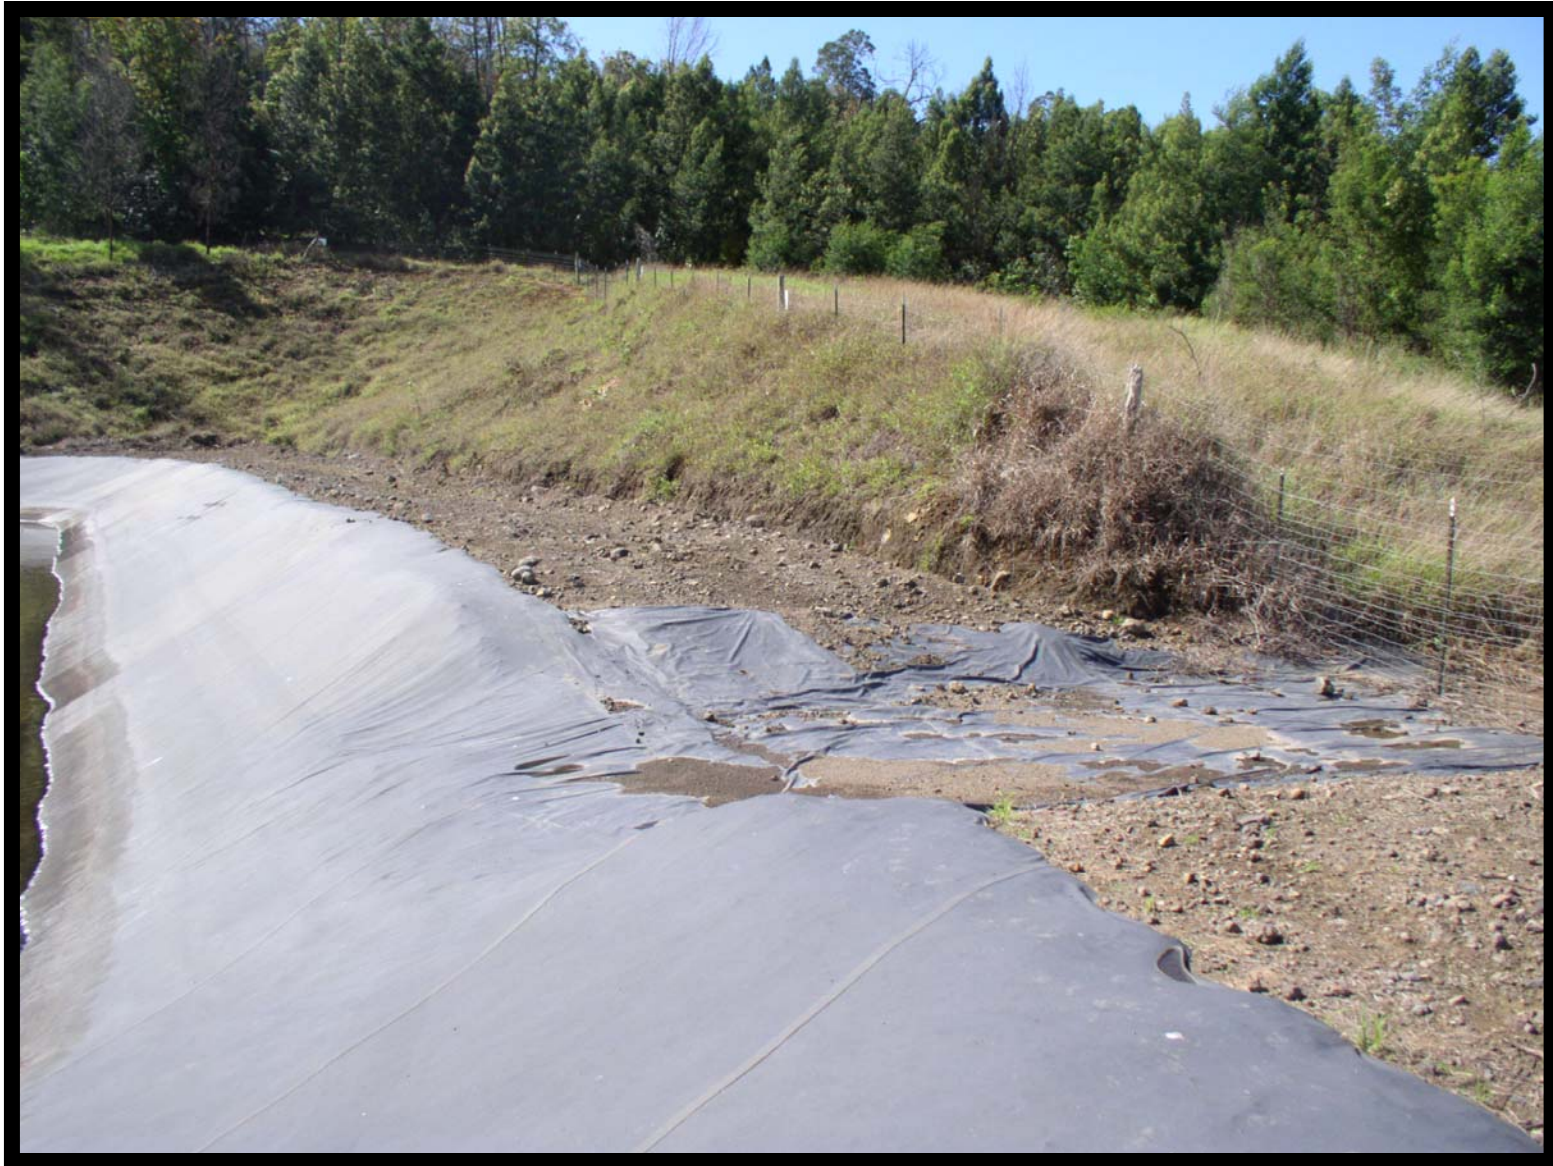
139 Uncontrolled spillway entrance (lined)
